I need to get rid of the grease in my lift station. I heard about using bacterial products. How do I know if they are working?

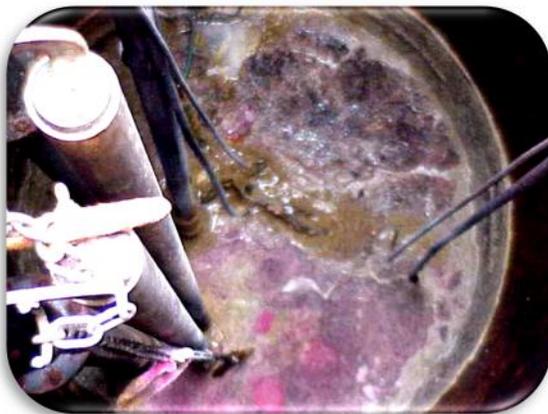
Cracks starting to form in thick hardened grease

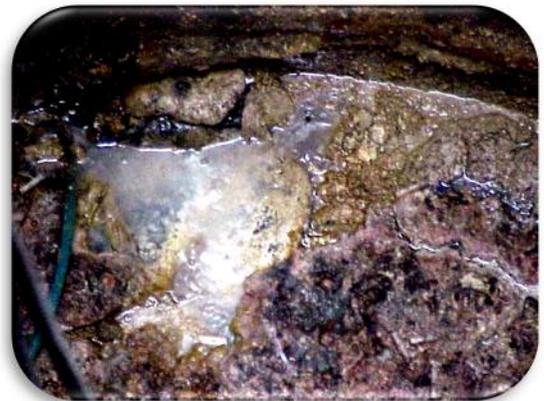
Application of product is improper here, pink product all over the top of the grease and not really in contact with the water

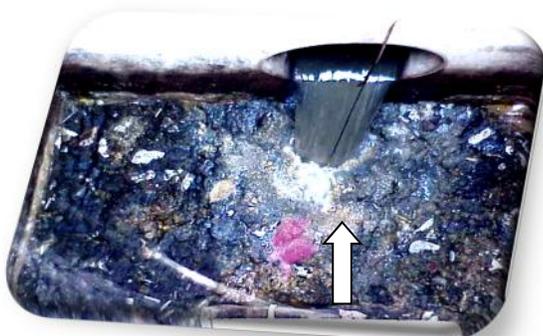
This lift station in top 2 images, before bacterial product (bioaugmentation) was introduced. There were thick solids built up in the corner & grease crust ledges.

This is a 5 Million Gallon a Day lift station that was filled with years of grease build-up.

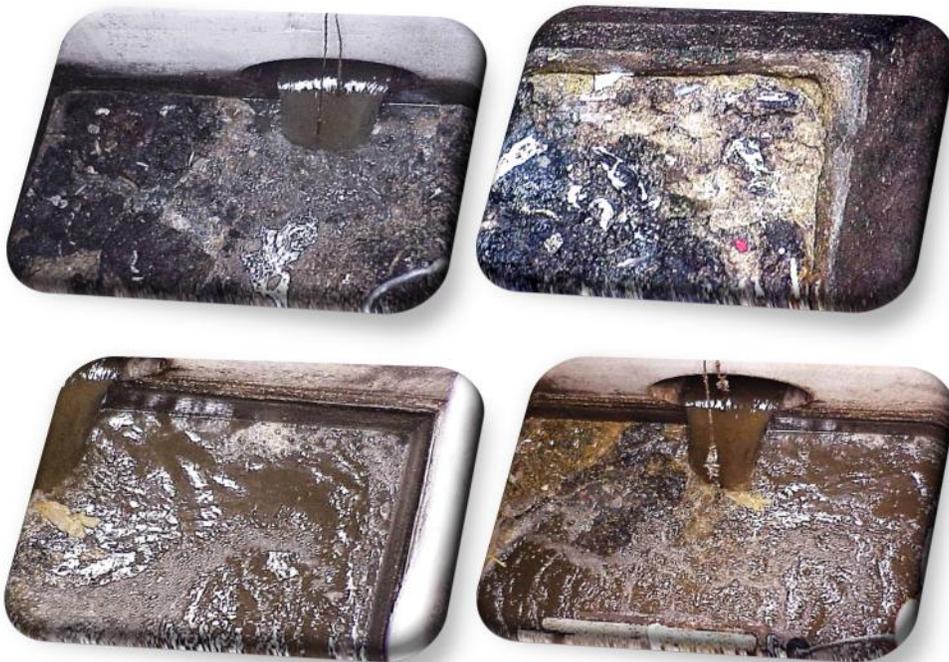
Here is how it looks now after using Environmental Leverage's bacterial products to remove the grease. Proper flow & movement now.

Except for a little bit of solids in the upper left corner, most of the grease and solids build-up are gone. Here is the upper right corner- clean and free flowing water as opposed to the above picture prior to addition of our biological products. The grease ledge is gone, the solids and chunks of grease are dissolved and there is circulation of water and better mixing.
