I need to get rid of the grease in my lift station. I heard about using bacterial products. How do I know if they are working?

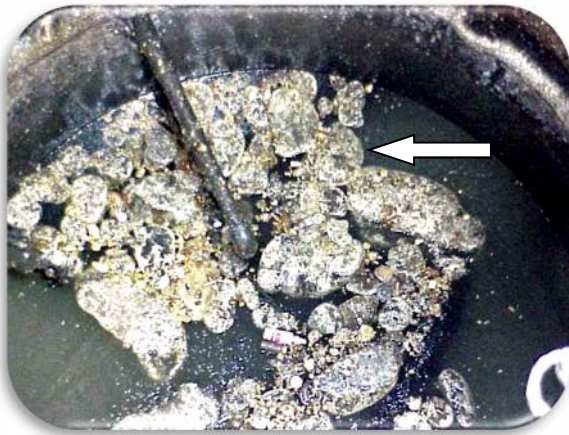
These have been called "Floating Turtles"- Hard solid formations that float around in the lift station. These can interfere with the pumps and can clog the pipes. Sometimes using a liquid product to spray on these can help reduce their size and shrink them faster.

Raising or lowering the float will not impact situations with turtle.

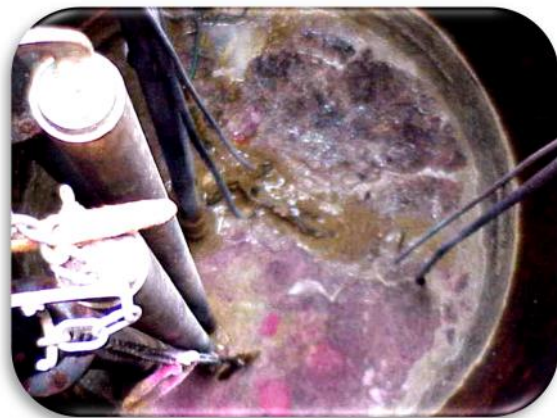
Cracks starting to form in thick hardened grease

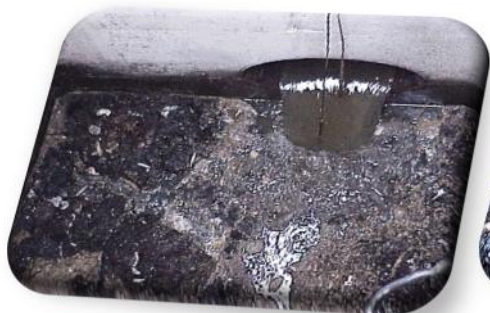
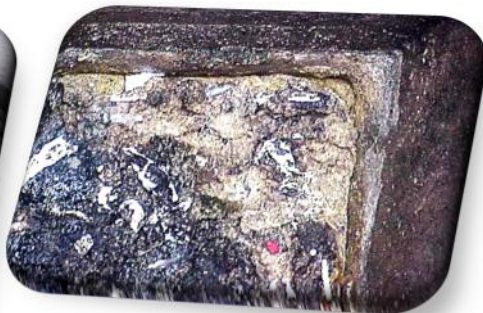
This lift station in top 2 images, before bacterial product (bioaugmentation) was introduced. There were thick solids built up in the corner & grease crust ledges.

This is a 5 Million Gallon a Day lift station that was filled with years of grease build-up.

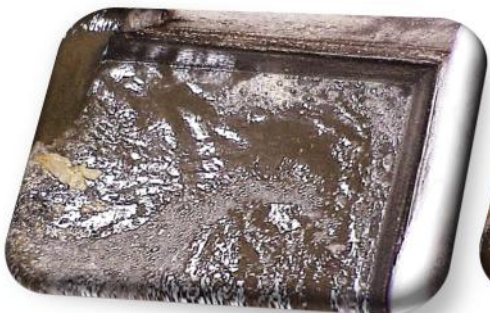
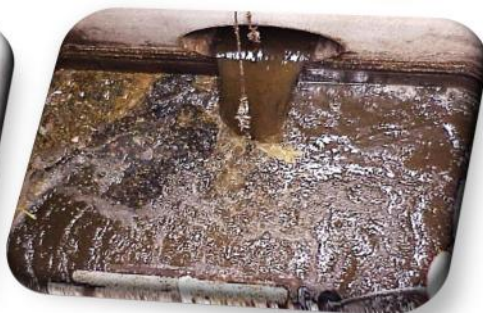
Here is how it looks now after using Environmental Leverage's bacterial products to remove the grease. Proper flow & movement now.

Except for a little bit of solids in the upper left corner, most of the grease and solids build-up are gone. Here is the upper right corner- clean and free flowing water as opposed to the above picture prior to addition of our biological products. The grease ledge is gone, the solids and chunks of grease are dissolved and there is circulation of water and better mixing.
