BAKERY AND SNACKS CASE HISTORIES

by Tracy Finnegan

BAKERY LIFT STATIONS

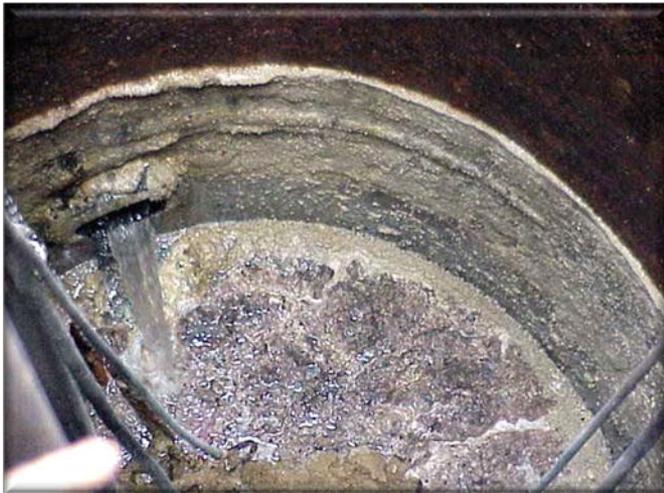
Grease in Lift Station

Grease in lift station
from Bakery

- Cookies, cakes,
pies

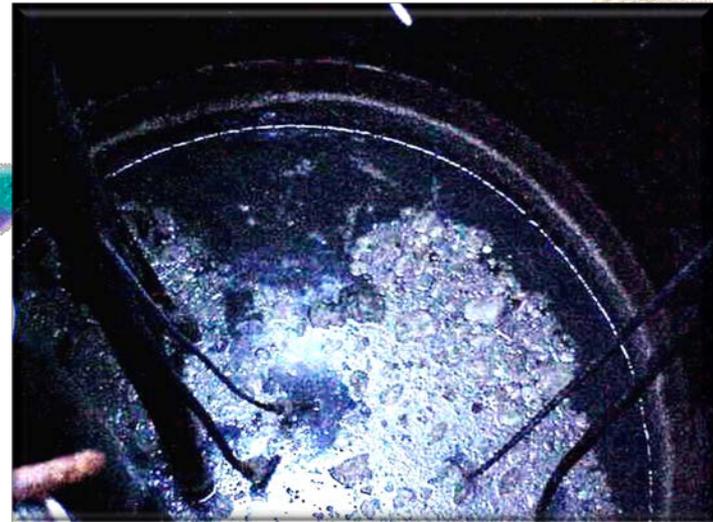
Lift station after only
2 weeks of
bioaugmentation
program

- A bioaugmentation program with bioblocks and the supplemental addition of nutrients was implemented into a lift station at a bakery. This bakery had fought grease issues for years and had tried other chemical and biological products.

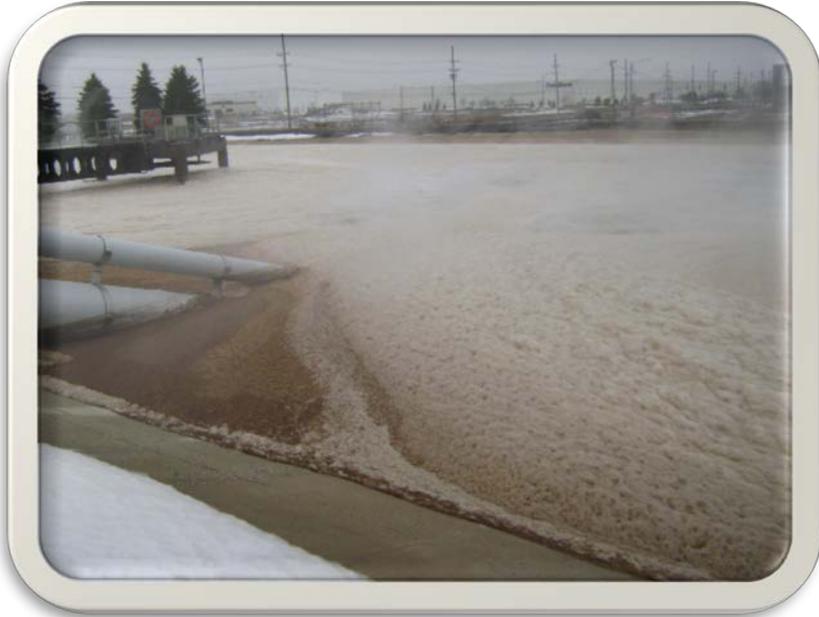
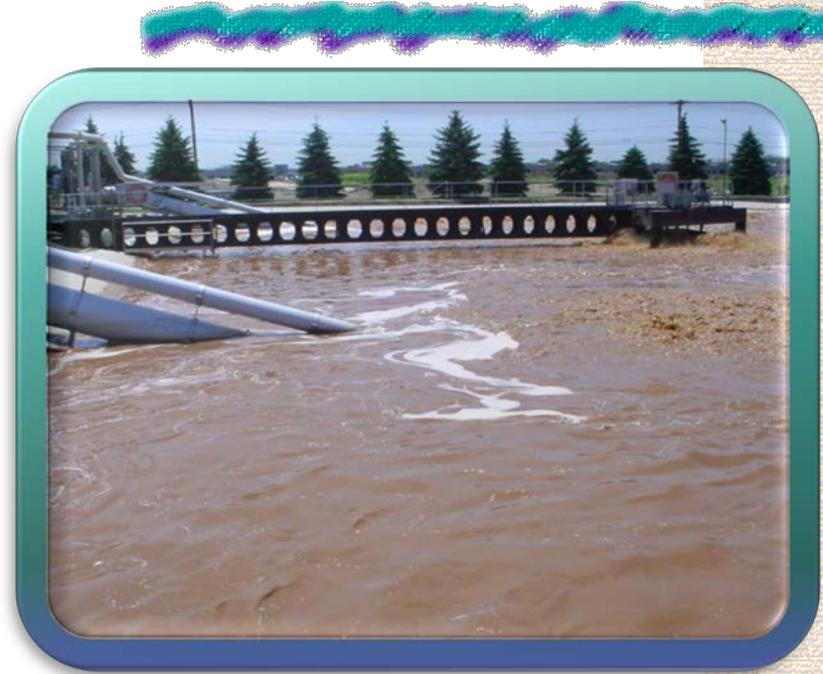
Foaming before and after bioaugmentation

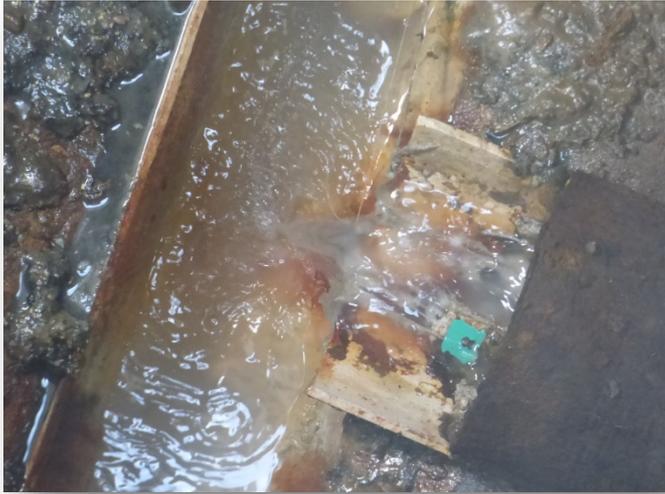
#4 Bakery Lift Stations

High levels of zooglea and slime in lift station due to oils and grease.

MicroClear® MicroBlock used to break down FOG.

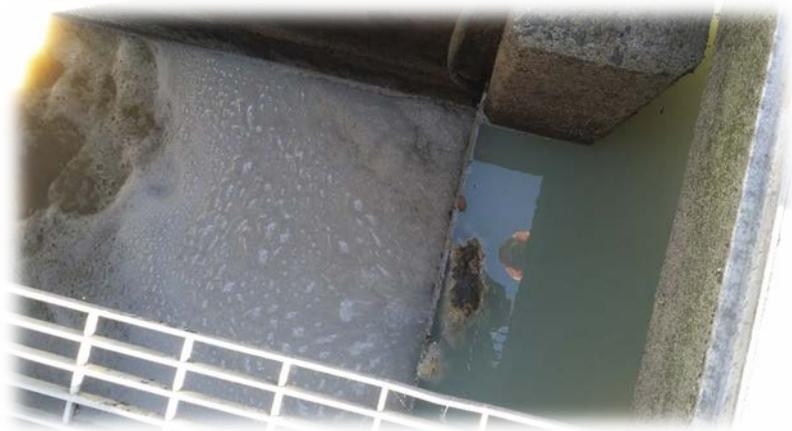
#5 Snack Factory East Coast

Oils from productions as well as lubricating oils causing high levels of organics

MicroClear® MicroBlock used in lift stations

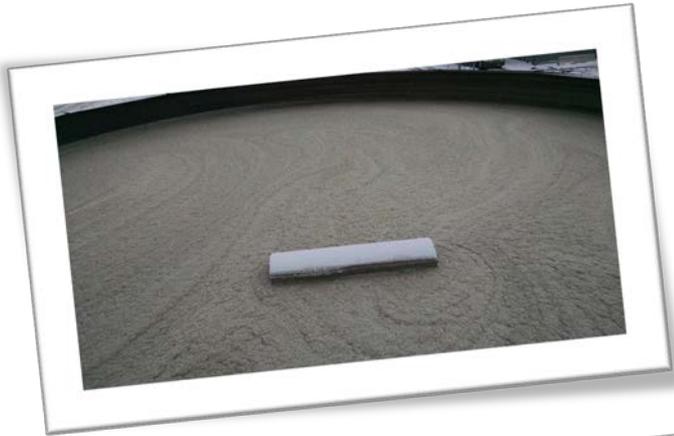
#6 Snack Factory Midwest

High foaming due to overload of BOD

Bioaugmentation w/
MicroClear® M100 and
MicroClear® 205 and
optimization of Critical 5
