Using the Microscope to Evaluate your System

We were asked to audit a plant up in the Alberta Oil sands. This plant had a small RBC unit. The main difference in a RBC unit vs. activated sludge is that you are trying to grow the bacteria on a fixed film media as opposed to suspended. All other principles of wastewater still apply.

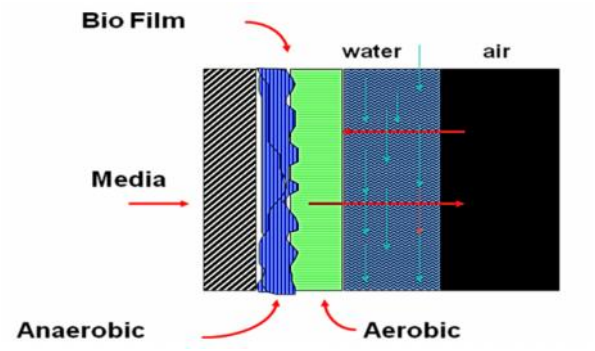
This RBC plant had issues with tiny pin floc in the clarifier going over the weirs and impacting TSS and fecal coliform counts. We pulled samples from two different spots, since this plant does not have screening upfront of the disks, but actually after the disks and prior to the clarifier.

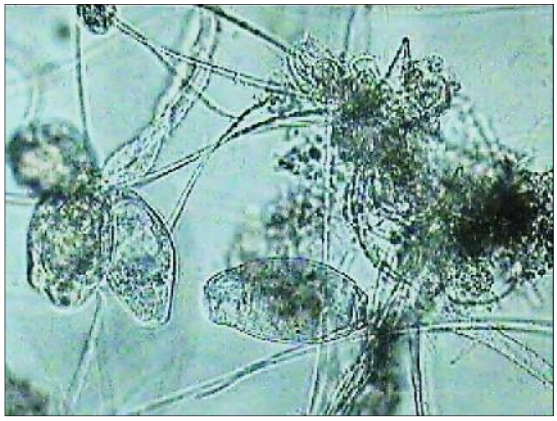
It was loaded with fiber, and excessive levels of filaments and spirillum. The floc structures were large, compact and with some very dark brown and black spots. Stalked ciliates were dominant, with a few rotifers and worms. As far as the higher life forms go, this is what you would expect from a RBC unit, relatively older sludge. The fiber was due to no prescreening and the filaments and spirillum indicates septic conditions. Some fungi was also present, indicating the septicity was lowering the pH.

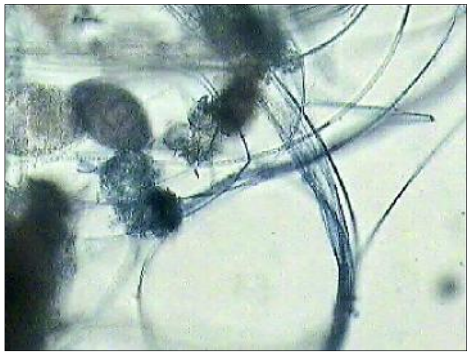
We pulled a sample prior to the screen, and found less fiber, and filaments. The RBC unit had a design flaw. The bottom collection system was rounded under the disks, yet the overflow to the clarifier was taken at a point relatively high up on the system, so solids built up on the bottom of the rounded collection pit. We ran a sludge judge and found quite a bit of solids. Again, we looked under the microscope. High levels of Type 021N filaments, spirillum, Thiothrix, Beggiatoa, fiber and black floc. Solids were sitting on the bottom and turning septic.

Sludge judge of solids on the bottom of the collection pit in the RBC- Lactophenol Cotton blue stains 400x Type 021n.

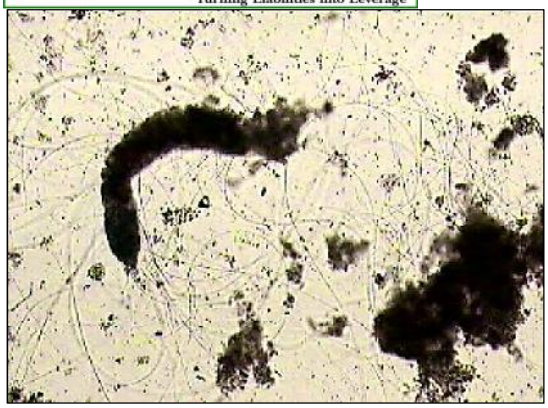
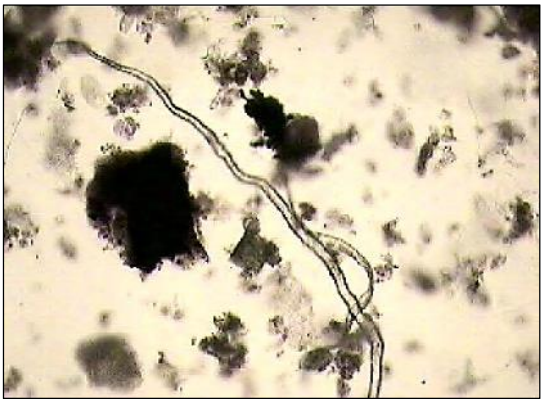
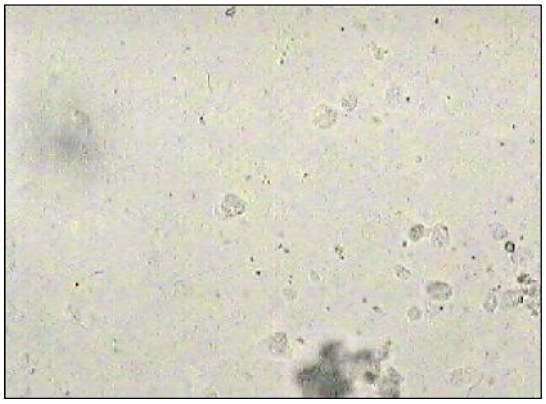
We decided to scrape samples off the RBC disk directly to see if the filaments were growing on the disks, or just in the screen and collection pit. We were quite surprised. Except for the areas where toilet paper and rags had collected on the disk and caused the biofilm to be trapped and turn older and septic, the majority of the biofilm was extremely young; amoebae and flagellates dominant. Floc was young, Zooglea was present.

Section 1-Some filaments in areas, probably where fiber or debris and rags built up solids. Some areas with floc and stalks. Fiber and floc in section two Amoebae and more single celled bacteria in section 3.

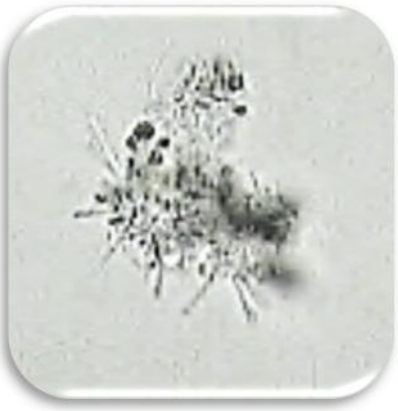
Black spots on floc, spirillum, tons of single celled bacteria, even Thiothrix II was present in the solids that were built up in the EQ and primary collection Tank. This plant did not have screens or a real primary clarifier, so no solids removal methods were in place. Instead solids were building up in the collections system upstream turning septic, EQ and primary were turning septic, screens and collections pit on the RBC were turning septic and the clarifier itself has solids build up on the slanted sidewalls that was turning septic, causing ashing and gassing and pin floc carryover.

Technically, if you look overall at all the samples and the results, although the final effluent shows pin floc, old sludge and septicity, the RBC disks themselves were actually very young. Changes to the operations were recommended based upon the sampling. Had we only tested one spot, we would never have found out the conditions present in all these spots……Use your microscope.
